## CHANGES IN STRESS LEVEL IN A CORRUGATED STEEL STRUCTURE UNDER LONG-TERM LOADS

Arkadiusz MADAJ\*, Krzysztof STURZBECHER\*\*

### Abstract

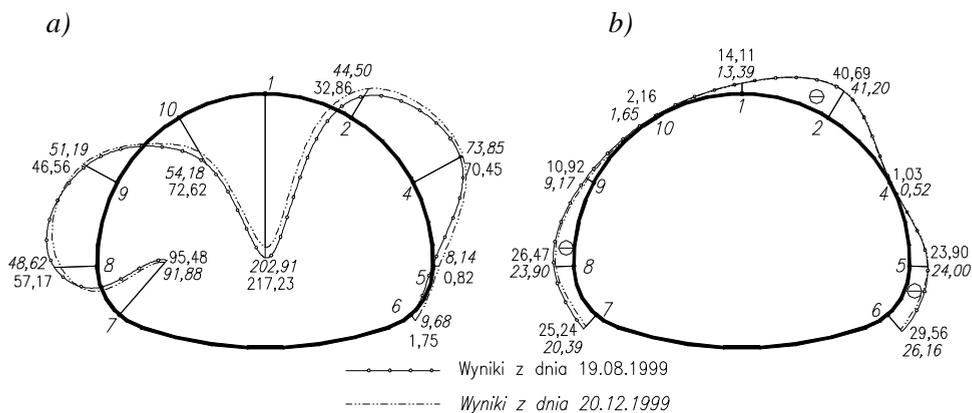
- during backfilling maximum stresses occurred during backfilling in the crown (point 1 –  $\sigma_{\max} = 240$  MPa; in the remaining points stresses were below 150 MPa (example of normal stress distribution shortly after commissioning is presented in Fig. 4)

Fig4 Stresses in the steel in 1999 [MPa]:a) Bending stress; b) hoop stress (“+” compression, “-“ tension; bending stress drawn in tension fiber side)

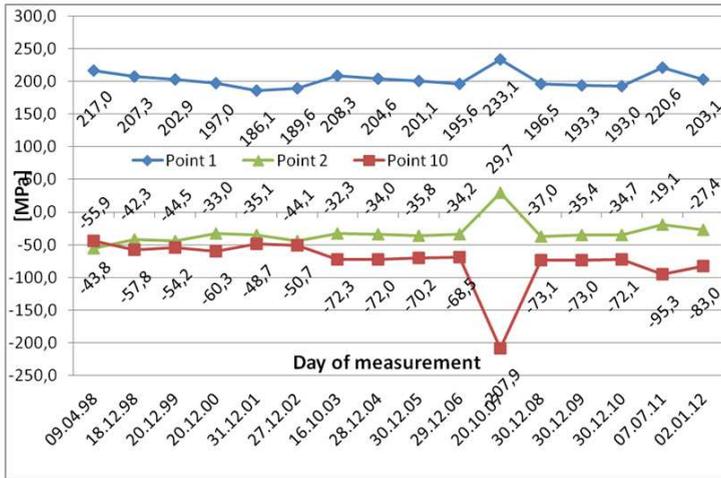
Fig. 5 Bending stress changes in points 1, 2 and 10 (near crown)

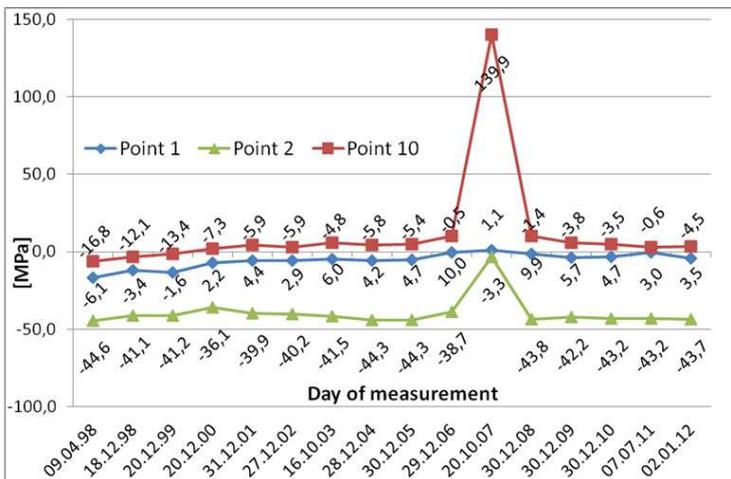
Fig. 6 Hoop stresses in 1, 2 and 10 (near crown)

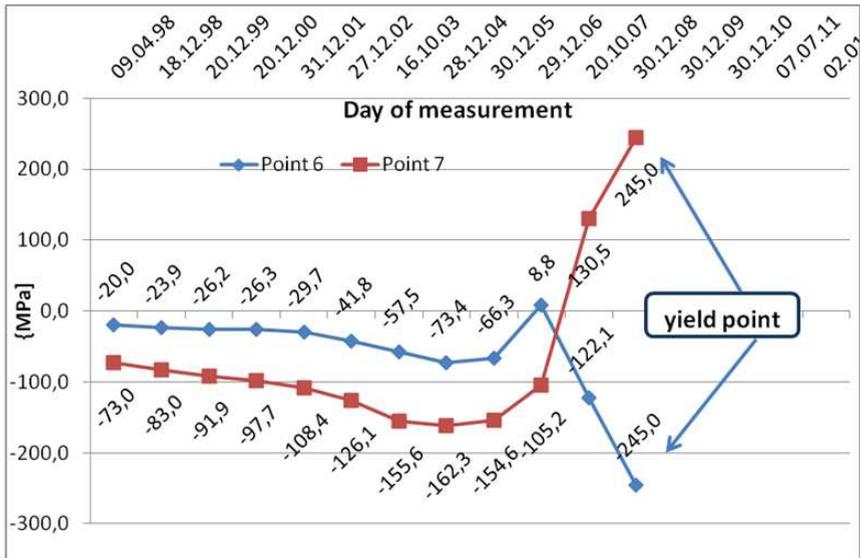
Fig. 7 Bending stress changes in points 6 and 7 (haunch)

- in 2007, so after 10 years of service, a significant change in points 6 and 7 caused the creation of a plastic hinge in these points (strain gages were damaged as a result),
- the creation of plastic hinges in the haunch resulted in short term change in distribution of stresses in other points,
- further measurements show that the values of stresses in other points (apart from the hinge) returned to the initial level.

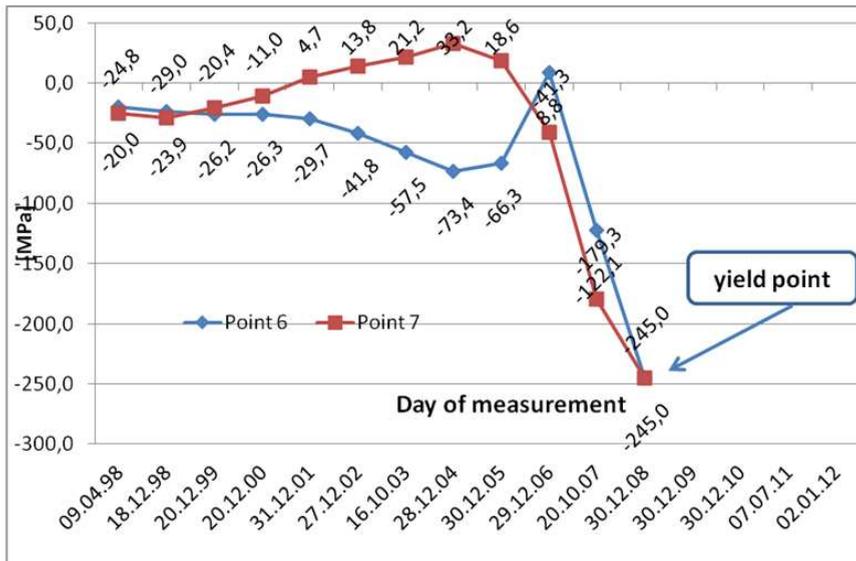
Fig. 8 Changes of hoop stresses in points 6 and 7 (haunch)
