LONG TERM OBSERVATIONS OF A 3-SPAN HIGHWAY CORRUGATED STEEL BOX BRIDGE ON GNIEZNO BYPASS

Arkadiusz MADAJ^{*}, Maciej WĘGRZYŃSKI^{**}, Leszek JANUSZ^{***}

The paper describes 5 years of behavior of a corrugated steel box 3 span bridge with a 14.1m span. The bridge is located on Gniezno by-pass in Poland. After few months of operation road surface over the bridge showed signs of ruts. An expertise was performed to evaluate causes of rut formation and provide suggestions for repair of the bridge. Deformations of road surface, structure and foundations were measured.

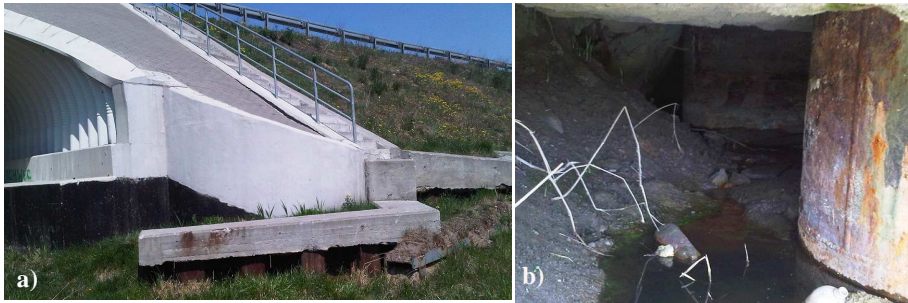
One year after the construction the road administration noticed signs of deflection of road surface located over the spans of the bridge. Moreover, settlement of soil at boths ends of the bridge abutment as well as underneath pile cappings were

recorded. In order to limit further settlement of embankment near bridge abutments, concrete restraining beams placed on Larsensteel piles were built in 2006 (Figure 4 a). It turned out, settlement persisted despite this installation. Figure 4b shows space under capping of the piles after 6 years of performance

Figure 4 a) View of concrete beams placed on Larsen steel piles (walls) at the bottom of the embankment; b) view of space under pile capping

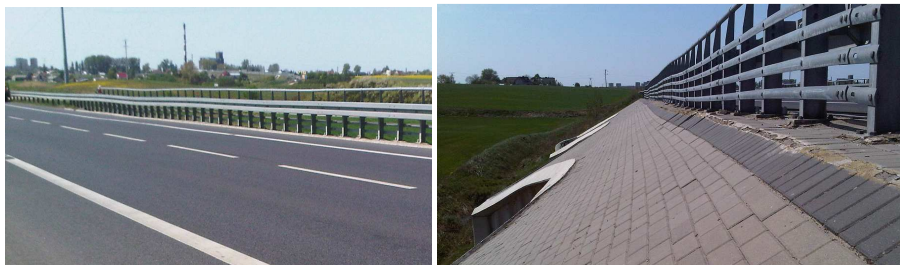
The deformations of the surface were reflected in the deformations of the steel bridge parapets which were installed alongside both ends of the bridge (Figure 5).

Figure 5 View of deformed parapets

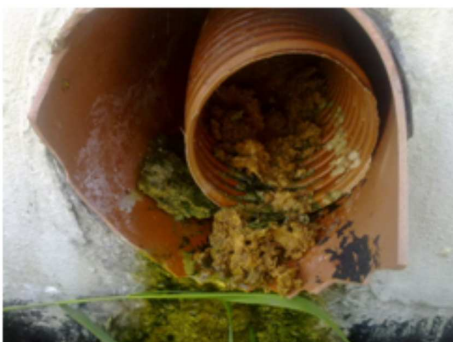
Fig. 6 Outlet of drain with fine particles that are washed - out from the backfill

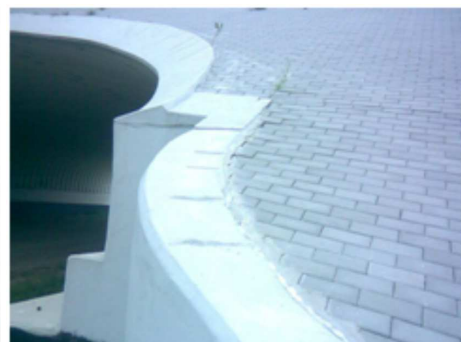
Fig. 7. Visible settlement of paved bevel end of the bridge

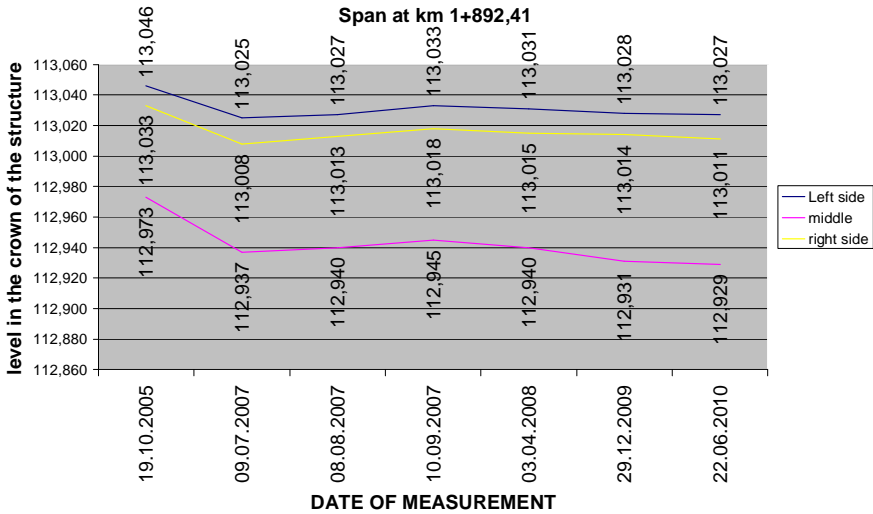
Fig. 9 Deflection measured in the crown of the corrugated steel structure in km 1+892,41

From the results obtained from measurements one can observe that there has been some deflection of corrugated structures in the crown. Maximum level measured over 5 years was 59 mm, which is 42% of the allowed deflection (140 mm) (CHBDC). Deflection has basically stabilized from 2007 to 2010. Deflections of the road surface were mostly progressing from 2005 to 2007 and since then the incremental change was minor, finally reaching the maximum level of 49 mm in 2008. There was no direct correlation between deflection of the road surface and deflection of the crown of the structures e.g. in km 1+892,41 in location (S) the final change in road surface was -0,024 m and the crown deflected -0,059 m. Opposite observations relate to other measurement points. Basically, foundations have been very stable. This conclusion was presented also in an expertise by (Madaj, 2008). Other independent expertise by (Gryczmański et al., 2008) concludes that the main result of the road surface deflection is settlement of the of road embankment at the abutments of the bridge. The difference between deflection of road surface in measurements points was caused by behavior of asphalt under live load (point S is located at road centerline which is affected less by the wheels of moving vehicles). In 2008 the top layer of road surface over the bridge has been replaced as the first repair measure. Observations of the bridge behavior from that moment on don't show alarming results. The bridge performs well. Authors are convinced that one of the reasons is that the consolidation of the soil has occurred and no major settlements of the embankment has occurred recently. Generally it is of importance when building such types of bridges to be especially careful with backfill and other surrounding soil that would contribute to soil-structure interaction in order to avoid problems during service.

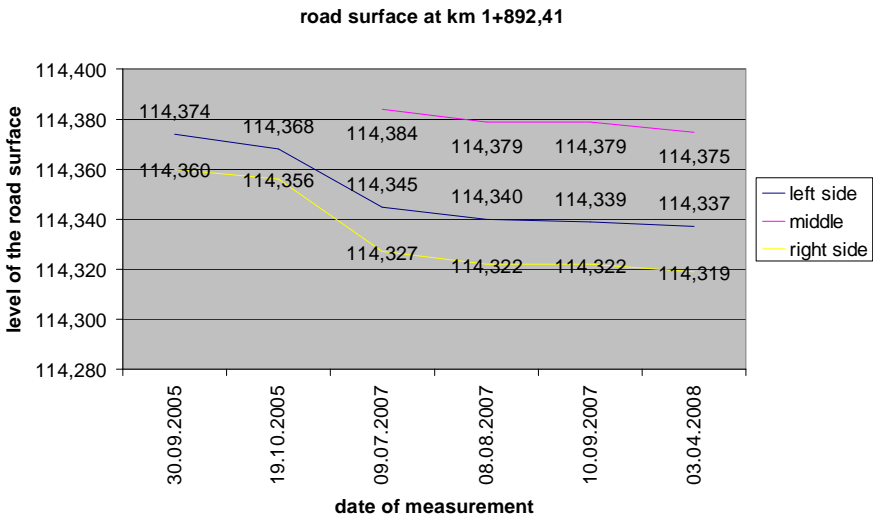
Fig. 10. Deflection of road surface measured in km 1+892,41

Changes between initial measurement and final measurement for asphalt road surface and crown of the span in left side (L), middle (S) and right side (P) locations were recorded. The below table shows maximum differences at km 1+892,41 (Table 1)
