## DEFORMATION CONTROL DURING ASSEMBLY AND BACKFILLING OF A CORRUGATED STEEL STRUCTURE, OSTRAVA, CZECH REPUBLIC

Adam CZEREPAK\*, Jaromir ZOUHAR\*\*

### Abstract

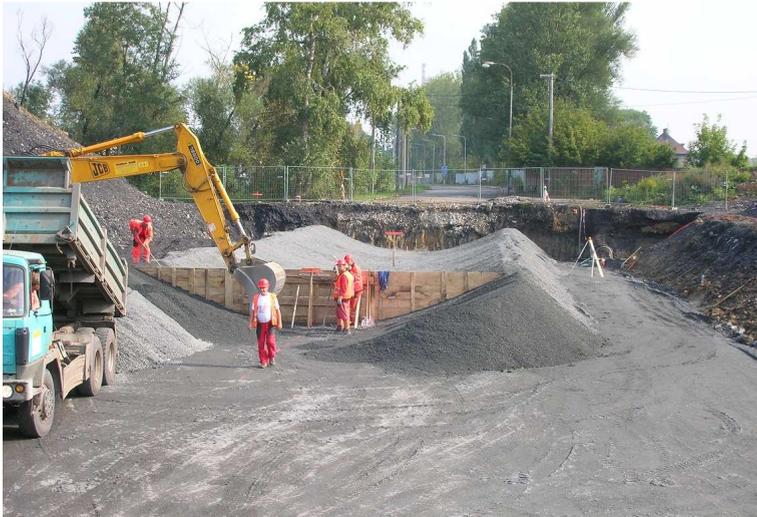
Fig. 2. Soil bedding preparation

Assembly took place during October and November 2009. Bedding under this structure was shaped to follow the shape of the bottom part of the steel profile (Figure 2). First measurement was done after assembly, registered as stage 0 (Figure 3 ). The shape of the structure after assembly was different than designed and deformation under dead load was observed. Deformation of the structure measured in the middle section is shown in Figure 4.

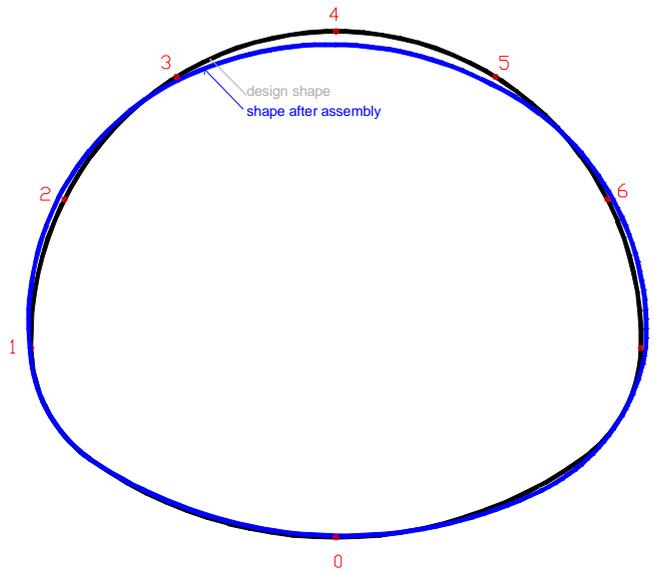
Fig. 4. Designed shape compared to the shape after assembly

Vertical displacement of measurement point no. 4 was 257mm.

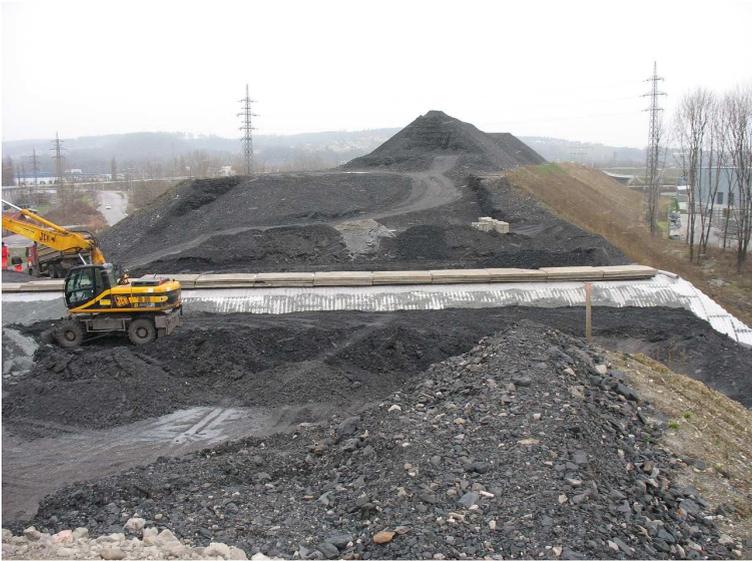
Fig. 5. Ballast with the use of concrete panels

During backfilling a few problems occurred. When backfilling material reached 8,7m from the bottom excessively large and fast deformation of the structure was observed and the contractor stopped backfilling. Crown point picked up around 32cm which accounts for 3,3% of the structure's height. Commonly acceptable deformation is 2-3% of dimensions.

Excessive deformation occurred because the compaction equipment used by the contractor was too heavy and worked too close to the structure.

After analysis, a decision to remove 3m of backfilling was taken and the contractor started backfilling again from the level of 5,7m, using light-weight compaction equipment. Moreover, the contractor together with the designer decided to put ballast on the crown of the structure using concrete panels (Figure 5) [3].

Backfilling with light equipment and with ballast allowed to keep deformation and shape of structure under bigger control [3].

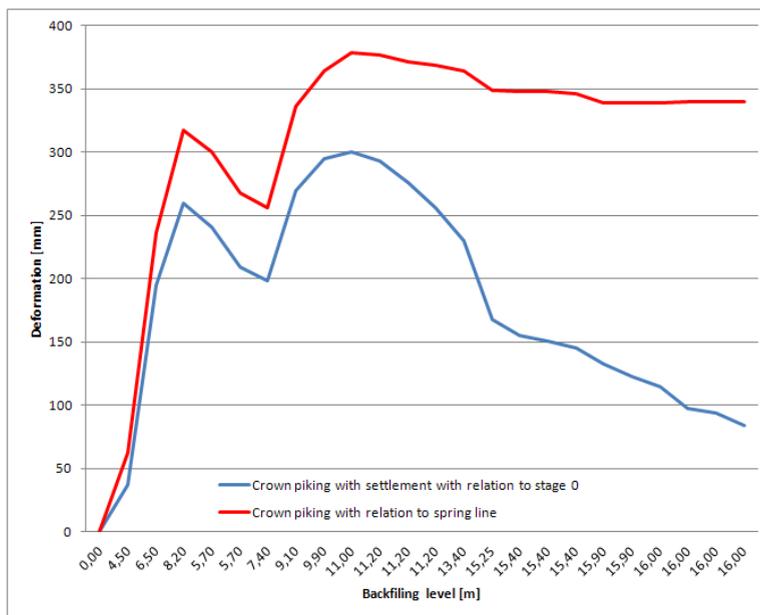
Fig. 6. Graph showing crown point picking during backfilling process and under live load

The biggest deformation was observed when the backfilling level was 11m, 1.1m above the crown of the structure – stage 9. Measurement point no. 4 in the crown picked up 30cm compared to stage 0 and 38cm compared to the level of spring line. It was the biggest horizontal deformation in stage 9, measurements point 2 and 6 moved towards inside of structure by 20-22cm in relation to stage 0 and between stage 9 and 23 these points moved back towards the outside of the structure because of loads from cover and traffic. After stage 9 measurement point no. 4 in the crown descended 4cm compared to the spring line. Last three measurement stages, 21, 22 and 23 were done during the first year from the time when the road was opened for traffic. No deformation of the structure was observed, but in the measurement result we can see settlement of embankment together with the structure. During this year the shape of structure didn't change. In table 1 below we can observe rising of point no 4 for each stage. Crown rise was calculated as a change in the distance between the spring line (horizontal line between points 1 and 7 from figure 4). Figure 7 shows crown picking in relation to the spring line (values from table 1) and second line with crown picking with relation to stage 0 where results include settlement of embankment.

Horizontal displacement of spring line (points no. 1 and 7 in Figures 4 and 6) didn't change significantly (0-5cm towards the inside of structure) and in final stage 23 with relation to stage 0 there was a 1-2cm difference only.

The final shape of the structure from stage 23, which was done in October 2011, is shown in Figure 6.
