FATIGUE TESTING OF A BOLTED CONNECTION FOR BURIED FLEXIBLE STEEL CULVERTS¹

John LEANDER*, Amer WADI*, Lars PETTERSSON*

*) KTH Royal Institute of Technology, Stockholm, Sweden

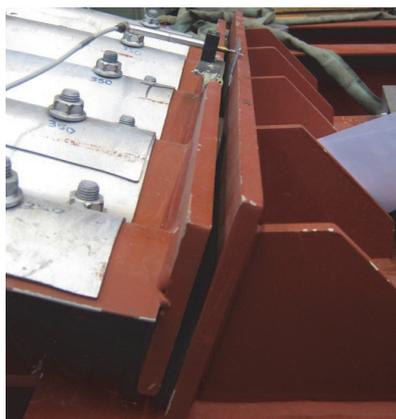
To attain a realistic combination of bending moment and axial force at the bolted connection, the supports were designed with tangential elastic springs and a hinge to allow rotations. A sketch and a photo of the support are shown in Figure 3. The intention was to reach a zero bending moment at the supports but this was not completely fulfilled. It is evident from the results that some restraining was present.

Figure 3. The support structure of the specimen

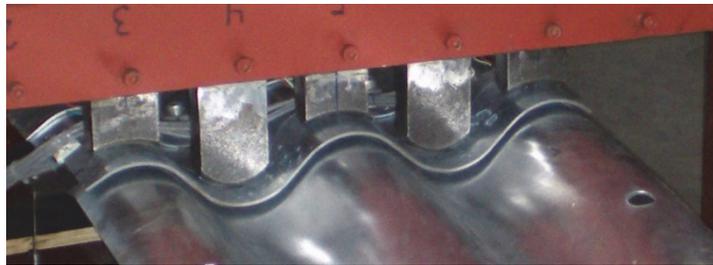
During one of the first tests a crack was initiated by the contact pressure at one of the teeth before any sign of cracks at the bolted connection appeared. In the subsequent tests, a protecting plate and a layer of neoprene were placed between the steel teeth and the specimen to avoid the concentrated contact pressure. A photo of one of the load lines is shown in Figure 4.

Figure 4. The adjustable teeth for loading the specimen and the protecting plate

Specimen 2 in Table 2 was treated as a runout because a fatigue crack appeared at a local indentation along the load line, not at the bolted connection. For the following specimens, a protecting layer was implemented as shown in Figure 4.

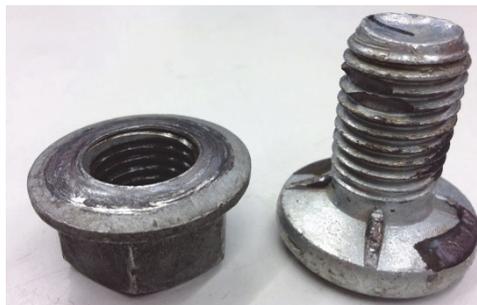
None of the specimens failed by fractures in the bolts. Minor defects and wear could be seen on the bolts after dismantling, see Figure 8, but no severe damage.

Figure 8. A bolt and nut after dismantling

The steel plates of the specimens had a cross-section corresponding to the trademark MultiPlate MP 200 profile [14] with a thickness of 3 mm and a corrugation height of 55 mm, see Figure 1. The bolted connection was composed of five bolts, three at the crests and two at the valleys. The bolts with class 8.8 and diameter of 20 mm had oval-shaped heads, with cams fixing the heads to the plates to facilitate mounting. The bolts were preloaded with a torque moment of 350 Nm. A photo of a bolt after testing can be seen in Figure 8.
