## DEFORMATION CONTROL DURING ASSEMBLY AND BACKFILLING OF A CORRUGATED STEEL STRUCTURE, OSTRAVA, CZECH REPUBLIC

Adam CZEREPAK\*, Jaromir ZOUHAR\*\*

### Abstract

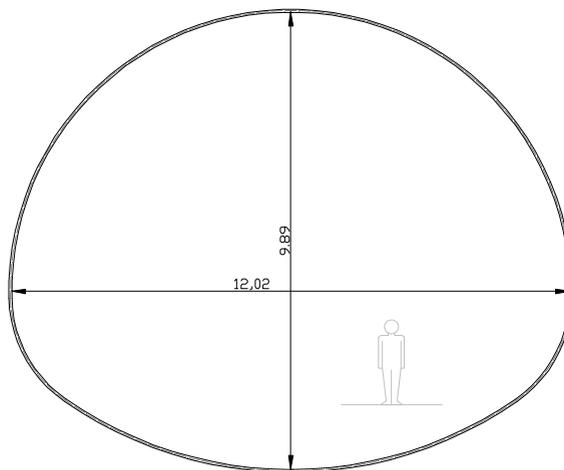
Fig. 1. Designed shape of MP200 profile used on viaduct in Ostrava

Pipe-arch profile was chosen (Figure 1 shows a cross section of this structure) with the following parameters:

- span 12.02m
- rise 9.89m
- bottom length 58.50m
- top length 48.00m.
- 7.00mm-thick plates
- 20 bolts/m. hot-dip galvanized bolts M20x50 and M20x45mm,

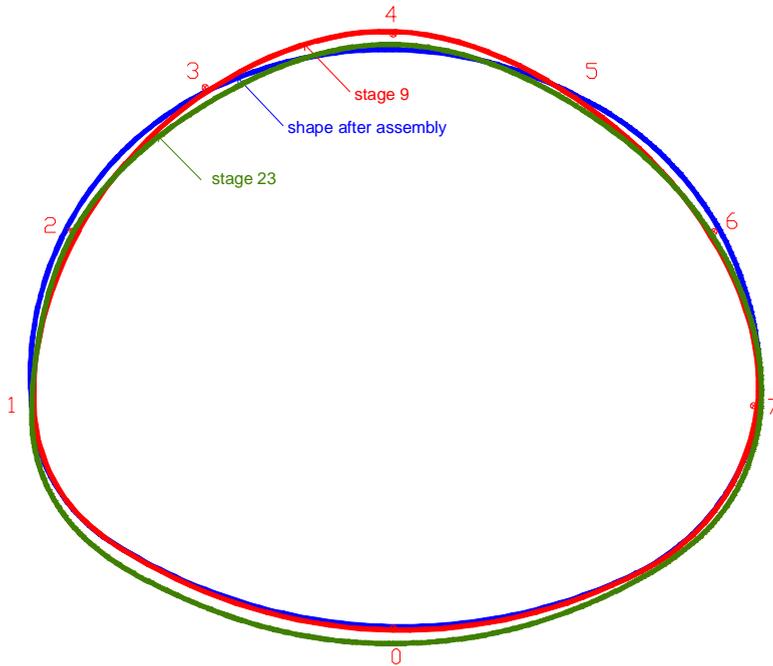
Fig. 7. Shapes comparison

The biggest deformation was observed when the backfilling level was 11m, 1.1m above the crown of the structure – stage 9. Measurement point no. 4 in the crown picked up 30cm compared to stage 0 and 38cm compared to the level of spring line. It was the biggest horizontal deformation in stage 9, measurements point 2 and 6 moved towards inside of structure by 20-22cm in relation to stage 0 and between stage 9 and 23 these points moved back towards the outside of the structure because of loads from cover and traffic. After stage 9 measurement point no. 4 in the crown descended 4cm compared to the spring line. Last three measurement stages, 21, 22 and 23 were done during the first year from the time when the road was opened for traffic. No deformation of the structure was observed, but in the measurement result we can see settlement of embankment together with the structure. During this year the shape of structure didn't change. In table 1 below we can observe rising of point no 4 for each stage. Crown rise was calculated as a change in the distance between the spring line (horizontal line between points 1 and 7 from figure 4). Figure 7 shows crown picking in relation to the spring line (values from table 1) and second line with crown picking with relation to stage 0 where results include settlement of embankment.

Horizontal displacement of spring line (points no. 1 and 7 in Figures 4 and 6) didn't change significantly (0-5cm towards the inside of structure) and in final stage 23 with relation to stage 0 there was a 1-2cm difference only.

The final shape of the structure from stage 23, which was done in October 2011, is shown in Figure 6.
