THE (NONE)DEFORMATION OF THE BIGGEST MP200 ELLIPSE UNDER HIGH COVER

Abstract

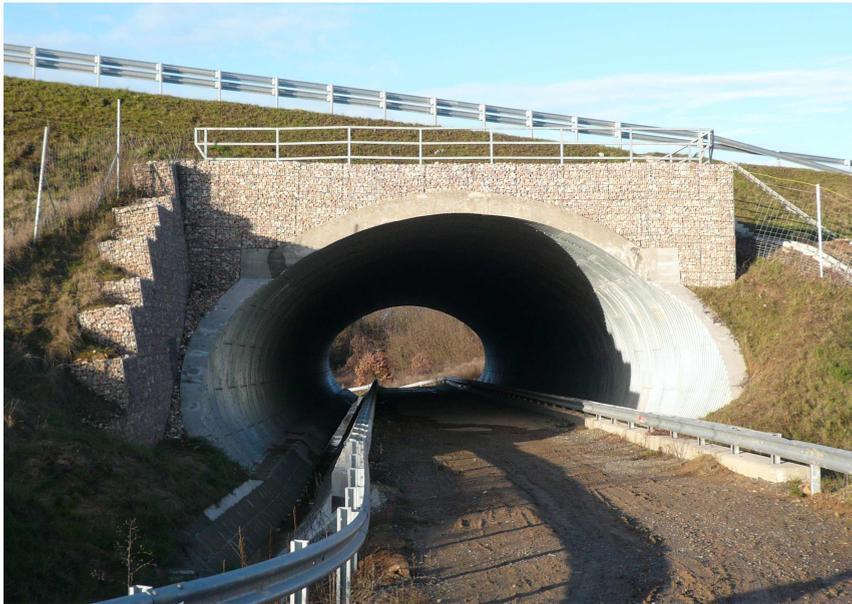
Figure 6. The VH42 structure under highway M60
